BYERS PIPE

BULLETIN No. 30

An Investigation of Pipe Corrosion

Showing service records of iron, steel
and brass pipe used for hot and cold
water supply lines in 129 Pittsburgh
Apartment Buildings

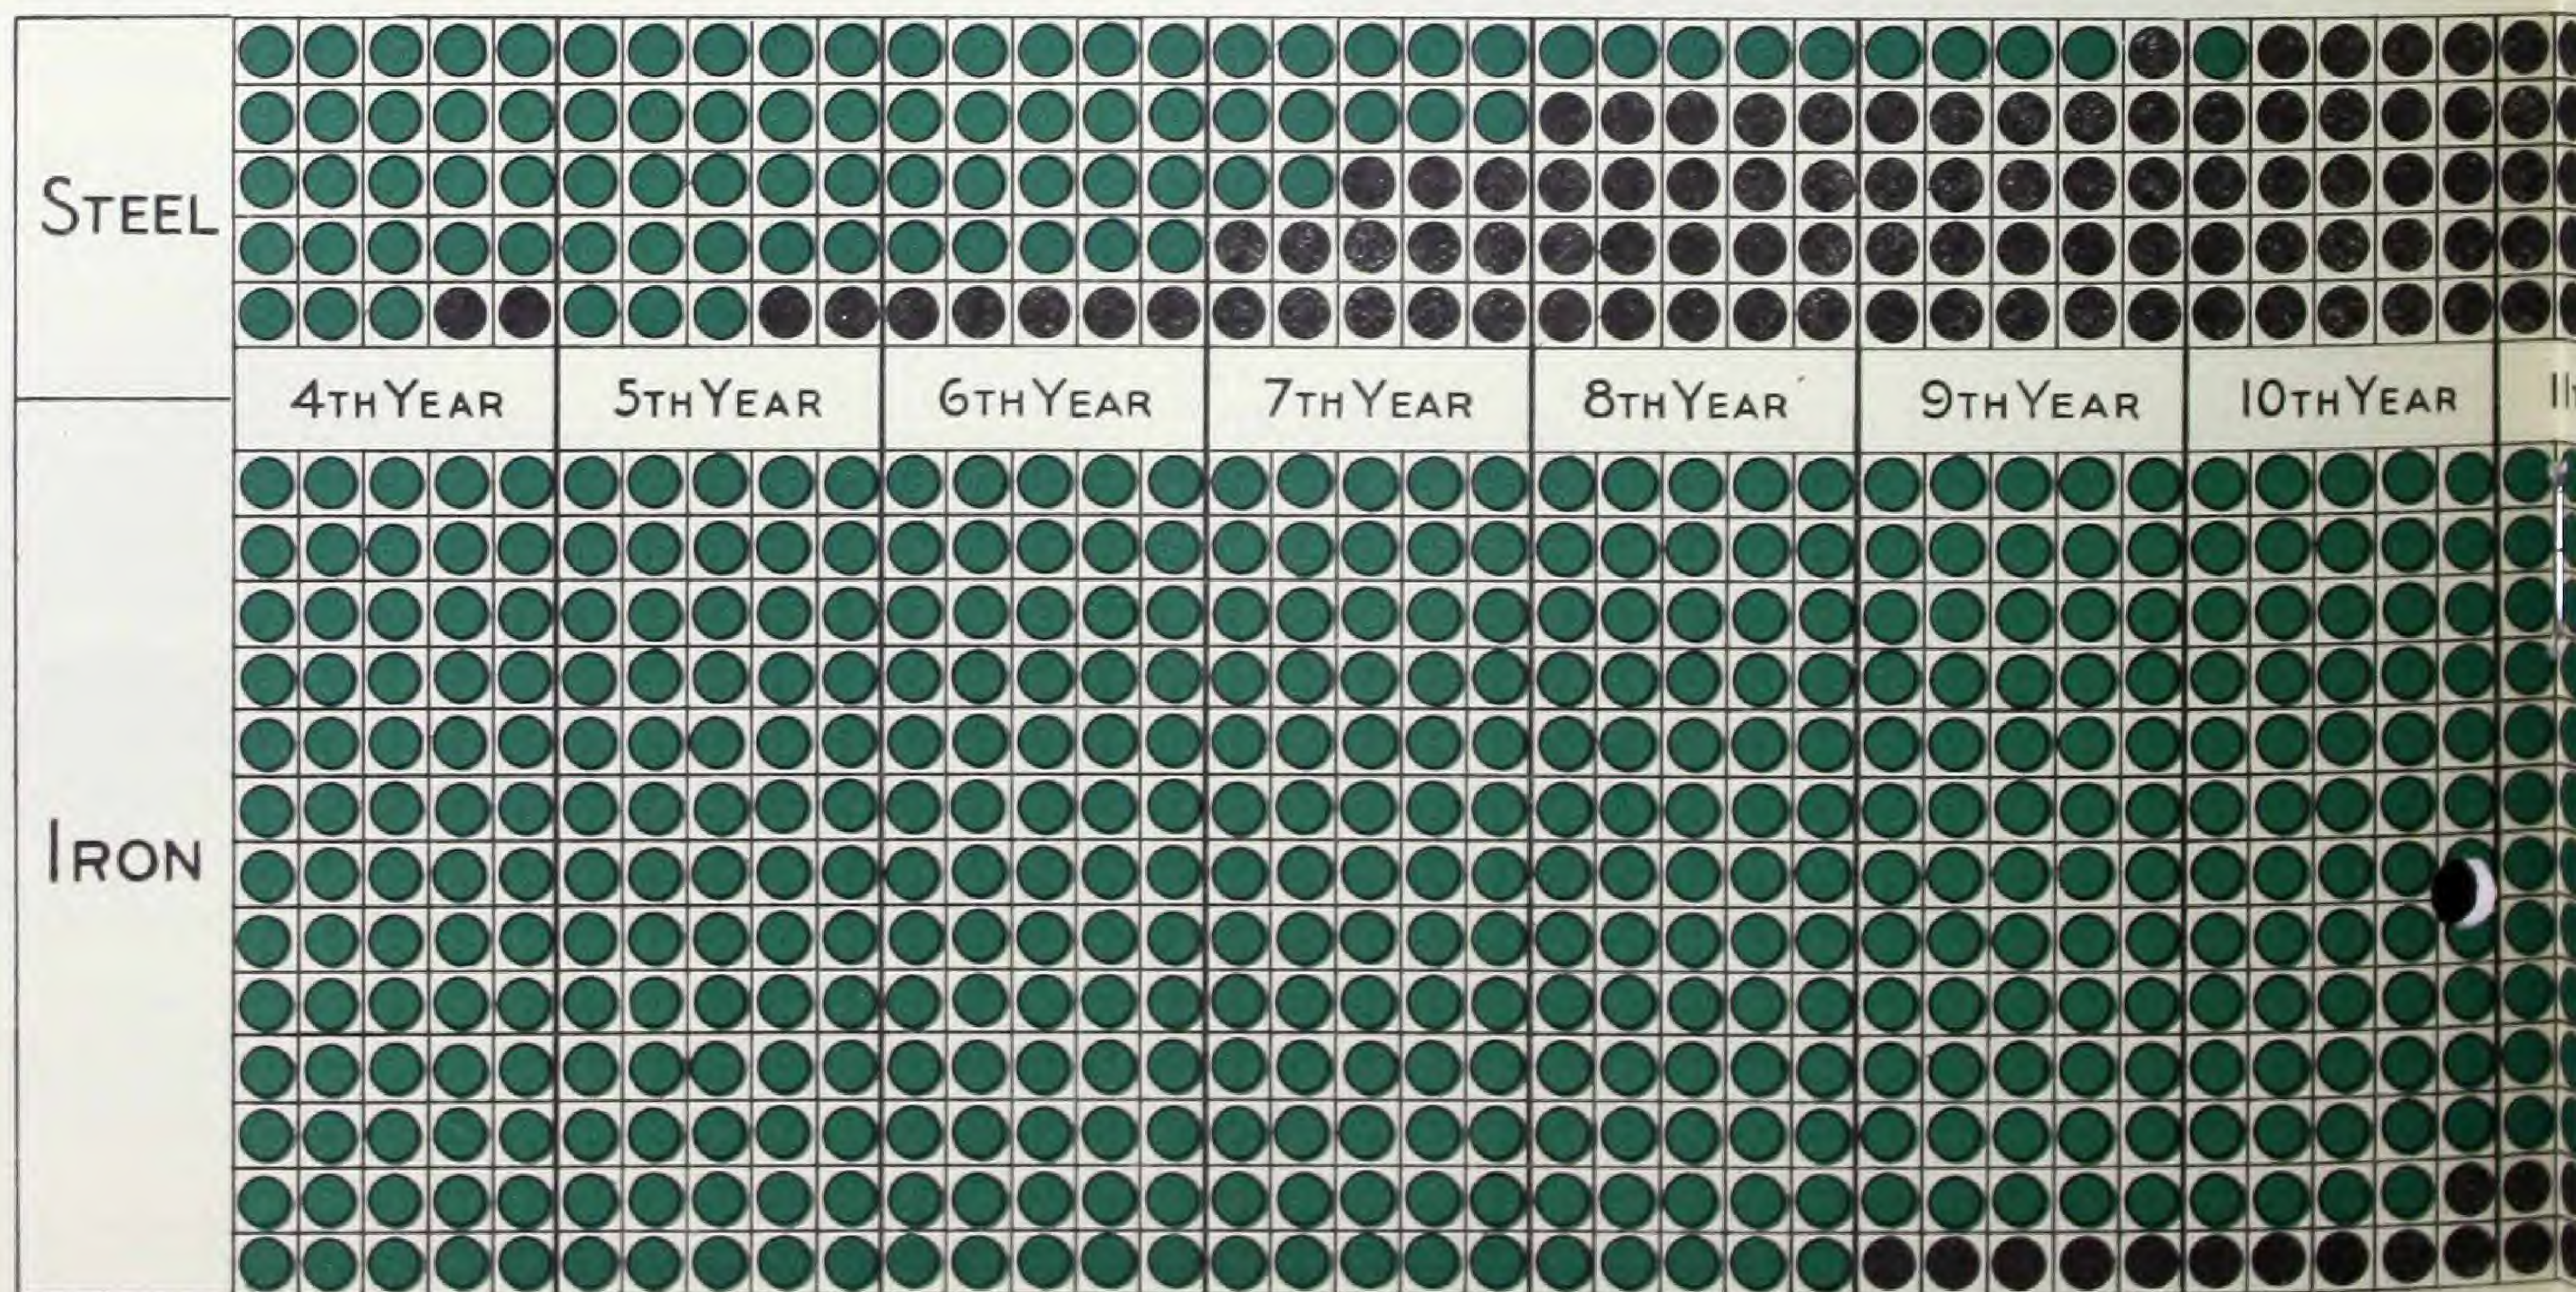
DOT CHART

Using a similar line of reasoning, we might point to the fact that certain steel installations lasted only 4 years and certain iron installations from 16 to 18 years, outlasting steel from 4 to 5 times. Likewise we might even undertake to claim—and with considerable good evidence to back this claim—that **extra heavy iron pipe lasts longer than brass pipe.**
